DESTATOR TEST PROGRAM EVALUATION

BATTELLE COLUMBUS LABORATORIES, OHIO

8 JULY 1976

REPORT NO. CG-D-¹³⁰~~57~~-76

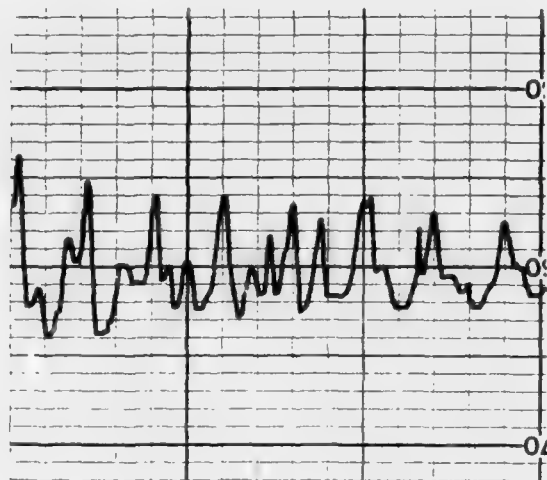
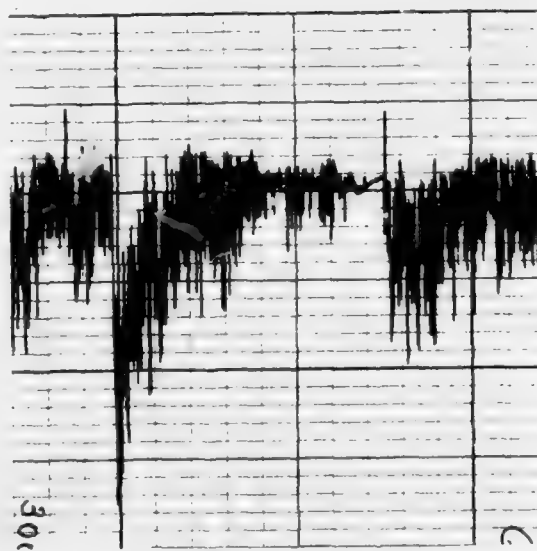
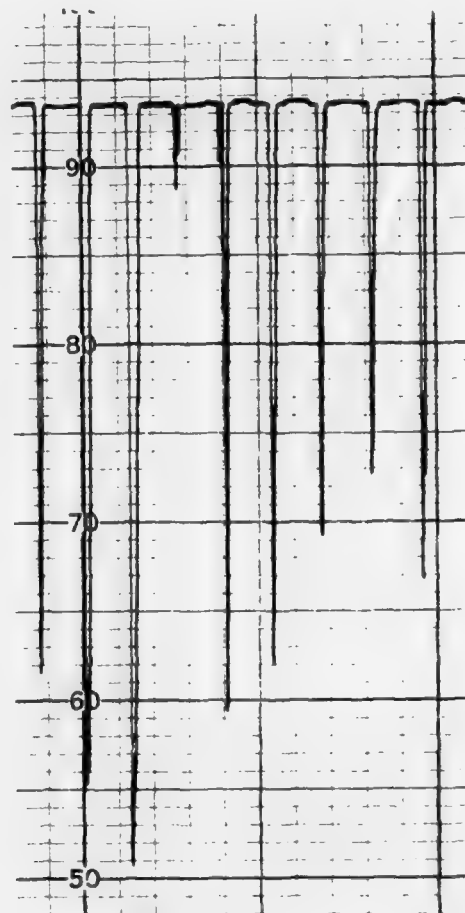
FIGURE 1. TRACES OF FIELDS RECORDED AT THE THREE CINCOTECH SENSORS

Throughout the tests, whenever the guncleans were in operation, the meter readings were pulsating. That is, the curve appeared to be the combination of two effects. One element of the curve was smooth; the other element of the curve was made up of sharp peaks and valleys. Several types of these characteristic curves (as recorded during the gas-free tests in Tank 8C) are illustrated in Figure 1. Curve (a) is the trace of the tube sensor (T) and illustrates the gradual rise in the recorded field with the random "negative" elements. Curve (b) is from the Destator sensor (D) and illustrates the saturated sensor at 15 kV/m with "negative" spikes. Curve (c) is the trace from the wall sensor (W). The spikes on Sensors T and D are attributed to the passage of water jets close to the sensor. The considerable trash on Sensor W is attributed to a direct hit into the head of the sensor. No meaningful values can be inferred from such a trace.

In the analysis and evaluation of these data, the actual value of the field was assumed to be the tops of the curves and, in general, the "spikes" were ignored. The justification for ignoring the spikes is that as soon as the guns were turned off, the curves smoothed out either at a value which would be interpolated from the preceding tops of the curves or slightly higher. In addition, many of the periods of spikes or trash as shown by the trace for Sensor W could be related audibly with the passing of a gunclean water jet.

Wall. Sensor W indicated zero field until approximately 1445 at which time an abrupt signal (similar to that shown in Figure 1c) of 65 kV/m was given. This reading tapered off to zero within 15 minutes but was followed immediately by a second buildup to a peak of 60 and decayed to zero within 18 minutes. These bursts occurred throughout the

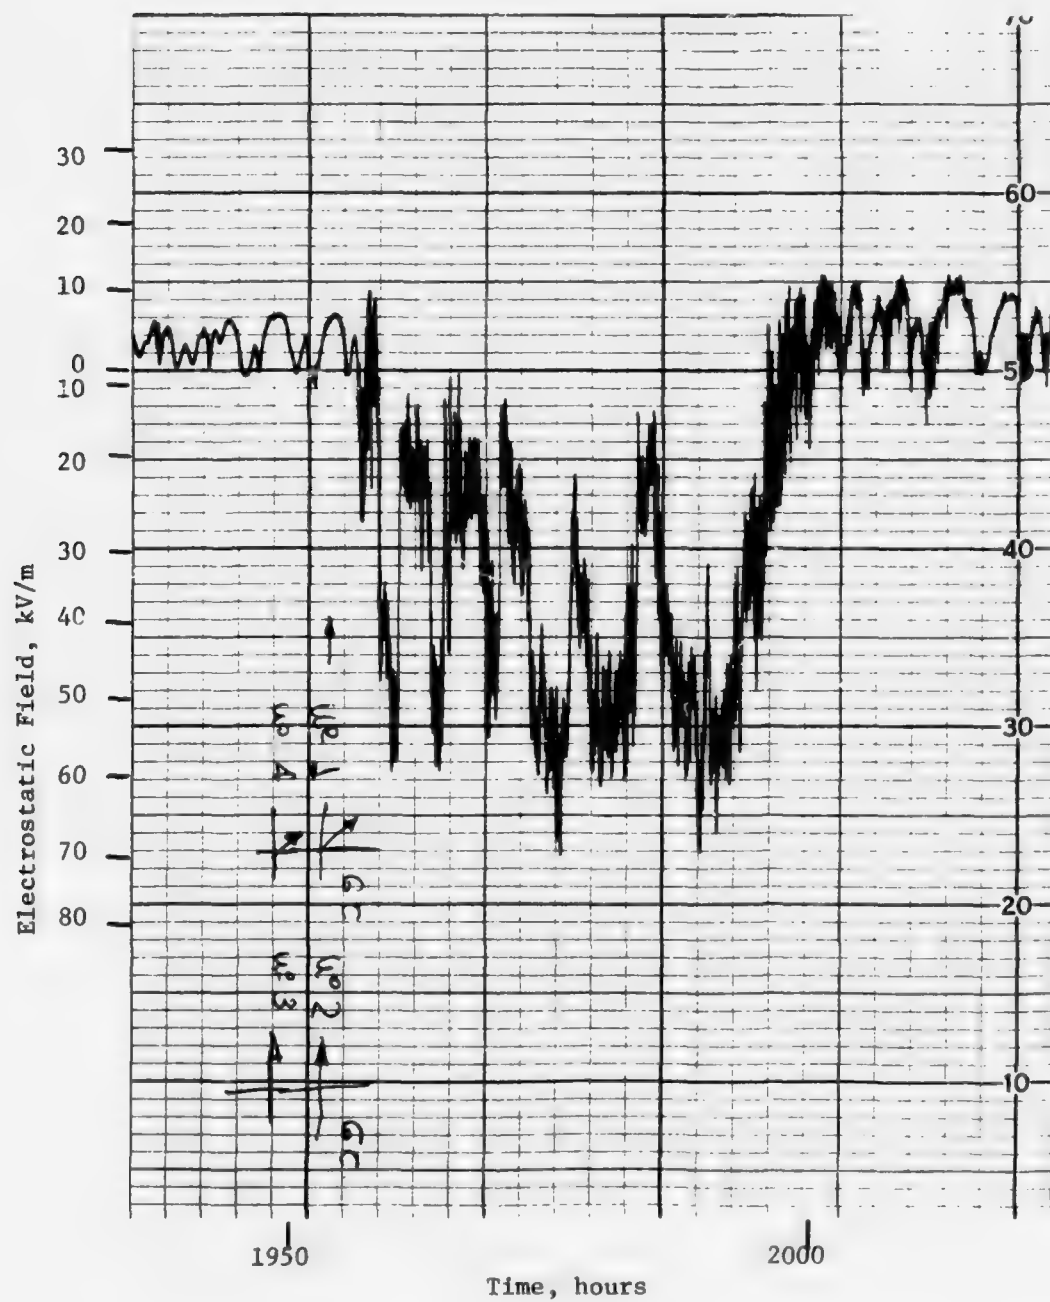
FIGURE 2. TYPICAL TRACE OF SIGNAL FROM WALL SENSOR
SHOWING NEGATIVE SIGNALS SUPERIMPOSED ON POSITIVE
